KOOTENAI DEVELOPMENT IMPOUNDMENT DAM SEPTEMBER 2011 ROUTINE OWNERS INSPECTION

Prepared for: The Remedium Group

Prepared by: Kurt Hafferman, P.E.

Inspection **D**ate: **S**eptember 29th, 2011 Report **D**ate: January 12th, 2**0**11

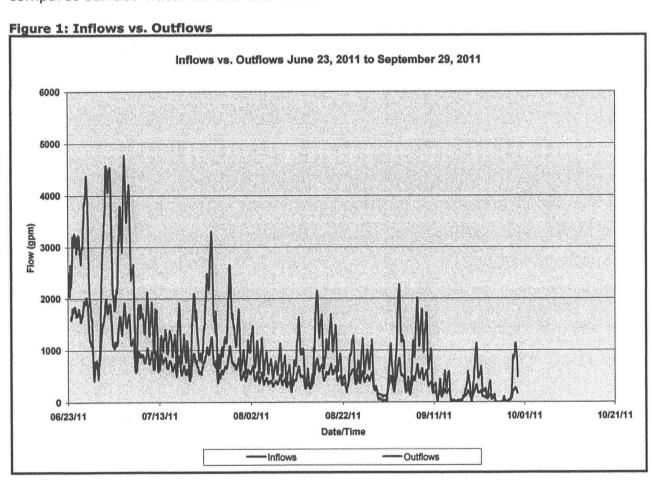
In the graph above, we can see that outflows have been consistently higher than inflows. Inflows include Upper Rainy Creek and calculated Fleetwood Creek flows and outflows include toe drain and spillway flow below the toe of the dam. Of particular interest are the continued matching flow patterns above and below the impoundment. As previously mentioned, there is not a calculatable lag time between

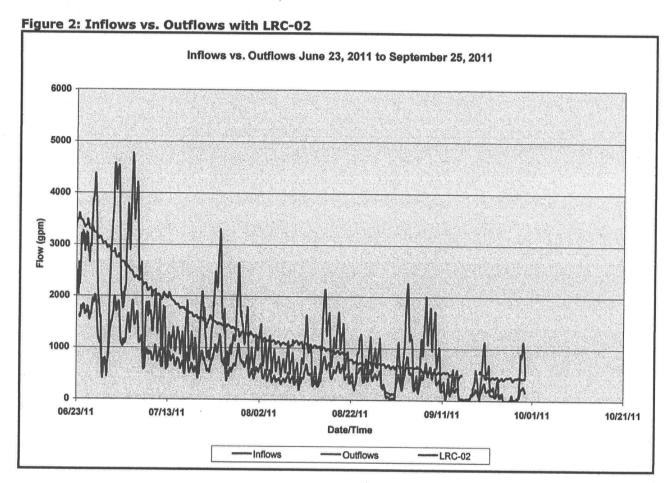
As previously discussed, the graph above is the same as Figure 1 except it includes the flow data obtained from MWH Global for the LRC-02 flume which sits below the mill pond. LRC-02 is measuring the same water as LRC-01 except for the addition of groundwater discharges and Carney Creek, which was removed in the graph above.

As can be seen, both the outflows at LRC-01 and LRC-02 are consistently higher that the inflows at URC-02, providing a second means to verify that outflow volumes are higher than stream inflows.

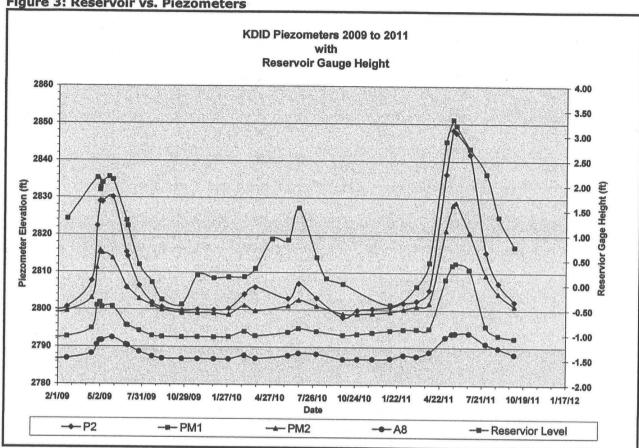
Figure 3: Reservoir vs. Piezometers

As shown above all piezometer levels are continuing to decline with falling reservoir and inflow levels; as is typical for this time of year. The transition to seasonally low levels continues to be near 1 month behind typical values measured and recorded onsite.

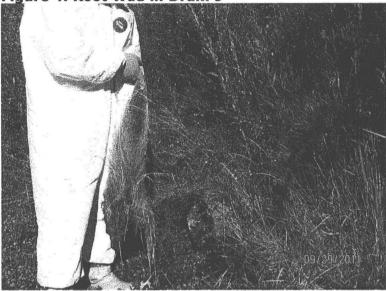
Figure 4: Root Wad in Drain 9

<u>Drain 9</u> shows lower flows than last month and correlates to the decreasing inflows on the project. A root wad was pulled from the pipe and is shown in figure 4 below. No sediment was noted as being trapped behind the root wad and no change in flow was noted.

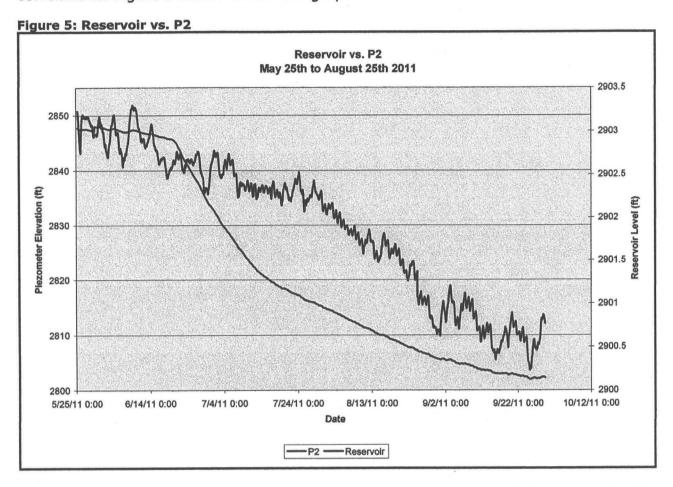
The graph above shows the continued decline of piezometer P2 and the reservoir. P2 showed no abnormal spikes or changes and as shown above is nearing typical low phreatic water surface levels. The piezometer has risen and dropped over 40 feet since peak levels were measured on May 18th this spring.

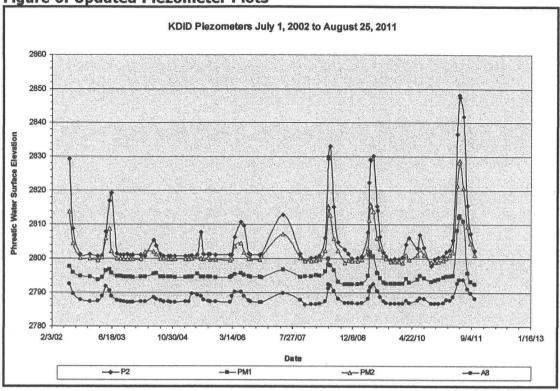
The graph above shows the highest recorded levels and well as the return to normalized levels and the annual cyclic changes that occur on the project. Figure 7 below shows the same piezometers, but over a shorter period of time.

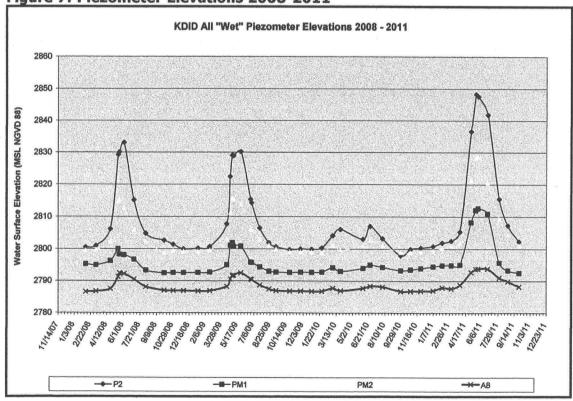
Figure 7: Piezometer Elevations 2008-2011

The graph above represents data collected since BHI began onsite inspections. We can see that piezometer A8 is dropping slower than the other piezometers on the site and shows the higher than normal phreatic water surface at the toe of the dam. Water levels this year at A8 have fallen slower than past years and indicate the volume of groundwater still present and moving below the dam. Figure 8 below shows the flat sustained peak in piezometer A8 at the toe of the dam that is not typical.

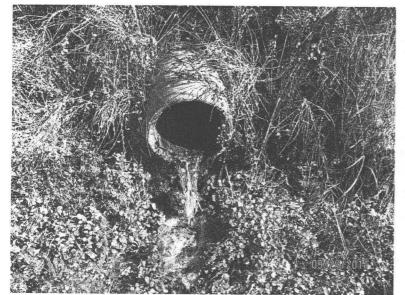
Root wad pulled from Drain 9
